# Visual Existing Conditions Report Walker South Landfill Phase 2 Environmental Assessment

Walker Environmental Group

Project name		Walker Sunrise						
Document title		Visual Existing Conditions Report   Walker South Landfill Phase 2 Environmental Assessment						
Project number		12567140						
File name		12567140 - Visual Existing Conditions - DRAFT Report.docx						
Status Code	Revision	Author	Reviewer		Approved for issue			
			Name	Signature	Name	Signature	Date	
S3	0	Emma Simioni Anna Zarina	Erika Brown		Blair Shoniker		2/11/2025	
S3	1	Emma Simioni Anna Zarina	Erika Brown		Blair Shoniker		2/27/2025

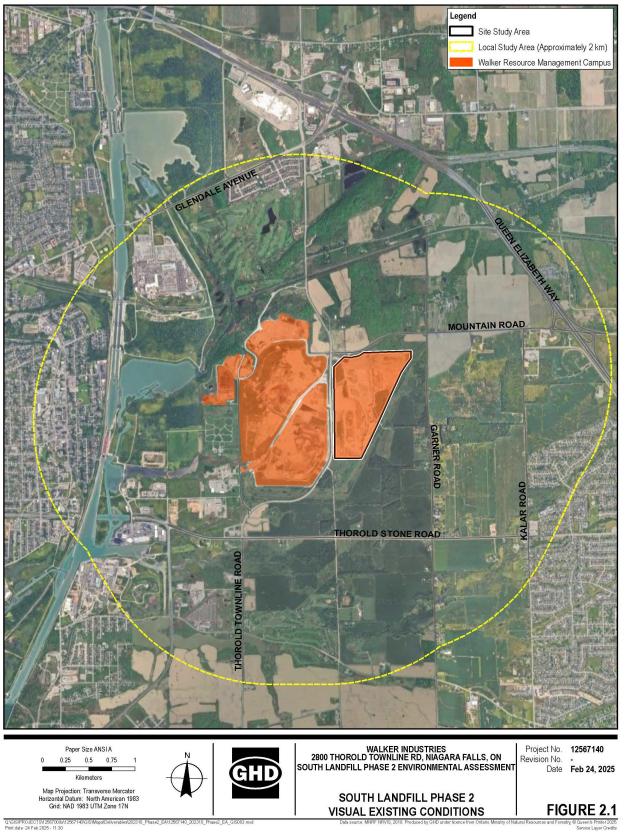
Figure 2.1 Visual Study Area

The SSA is common for all technical disciplines and includes all lands (76.12 hectares [ha]) owned and operated by Walker that are within the existing approved boundaries of the Southeast Quarry. **Figure 2.1** illustrates the extent of the SSA.

The LSA is specific to each technical discipline but generally extends approximately 1 to 2 kilometers (km) beyond the SSA boundary and can generally be described as including Walker's Resource Management Campus and the immediate surrounding area. **Figure 2.1** illustrates the LSA for this Visual Existing Conditions Report, which extends approximately 2 km from Walker's Resource Management Campus. The LSA was selected as a conservative

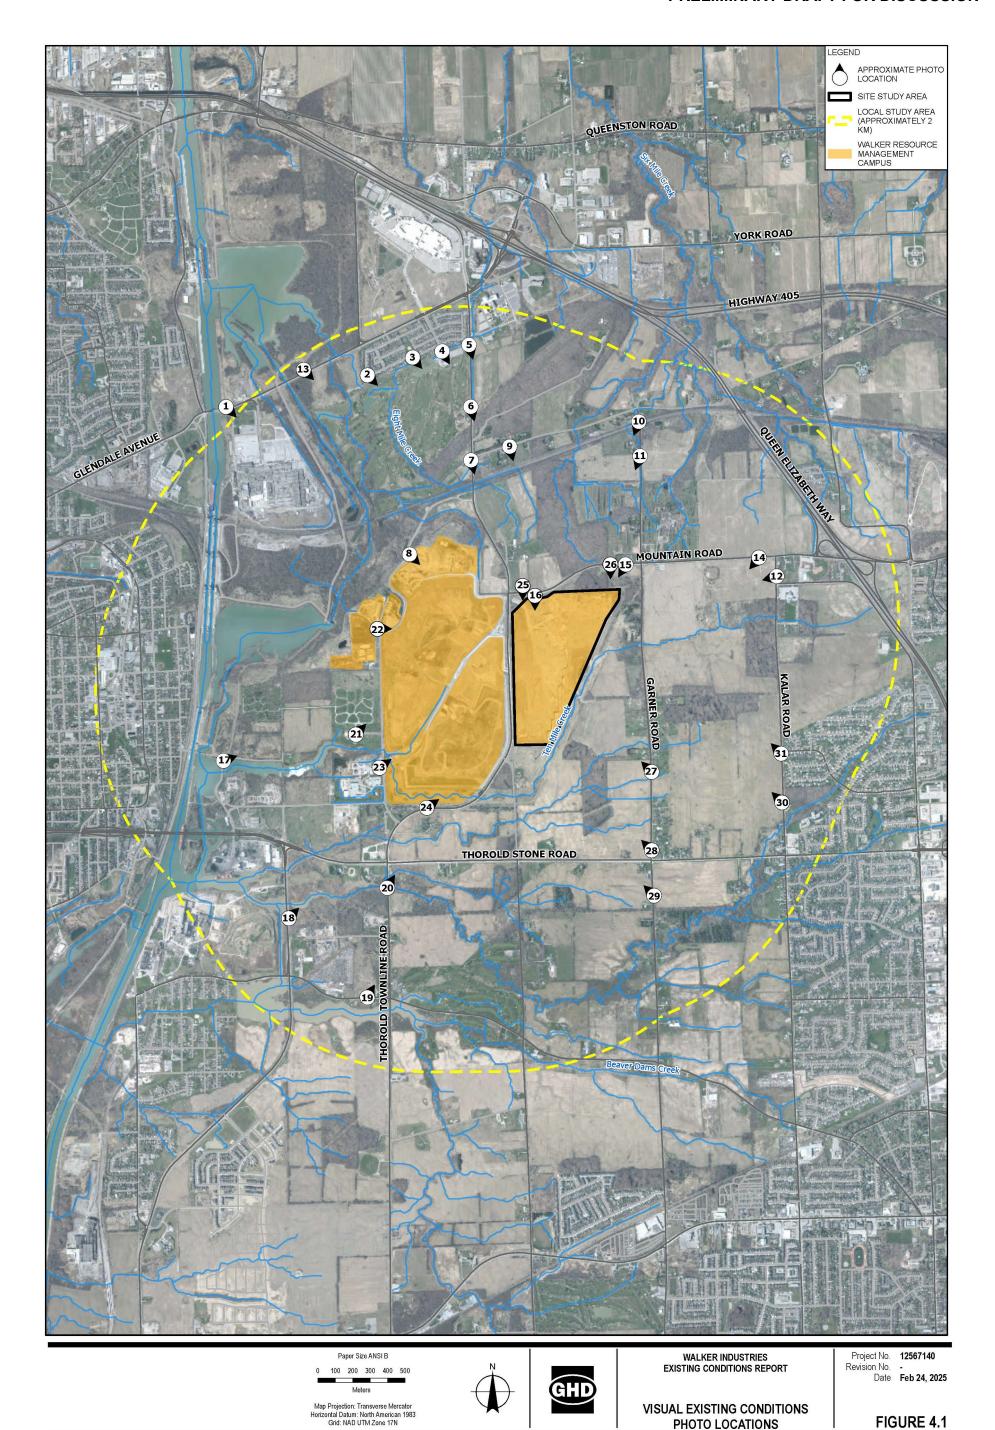
Figure 4.1

Views of the proposed South Landfill Phase 2 site from locations within the LSA are provided in the photo log below, and the locations from which each of the photos were taken are shown in **Figure 4.1**.

Visual Existing Conditions Photo Locations

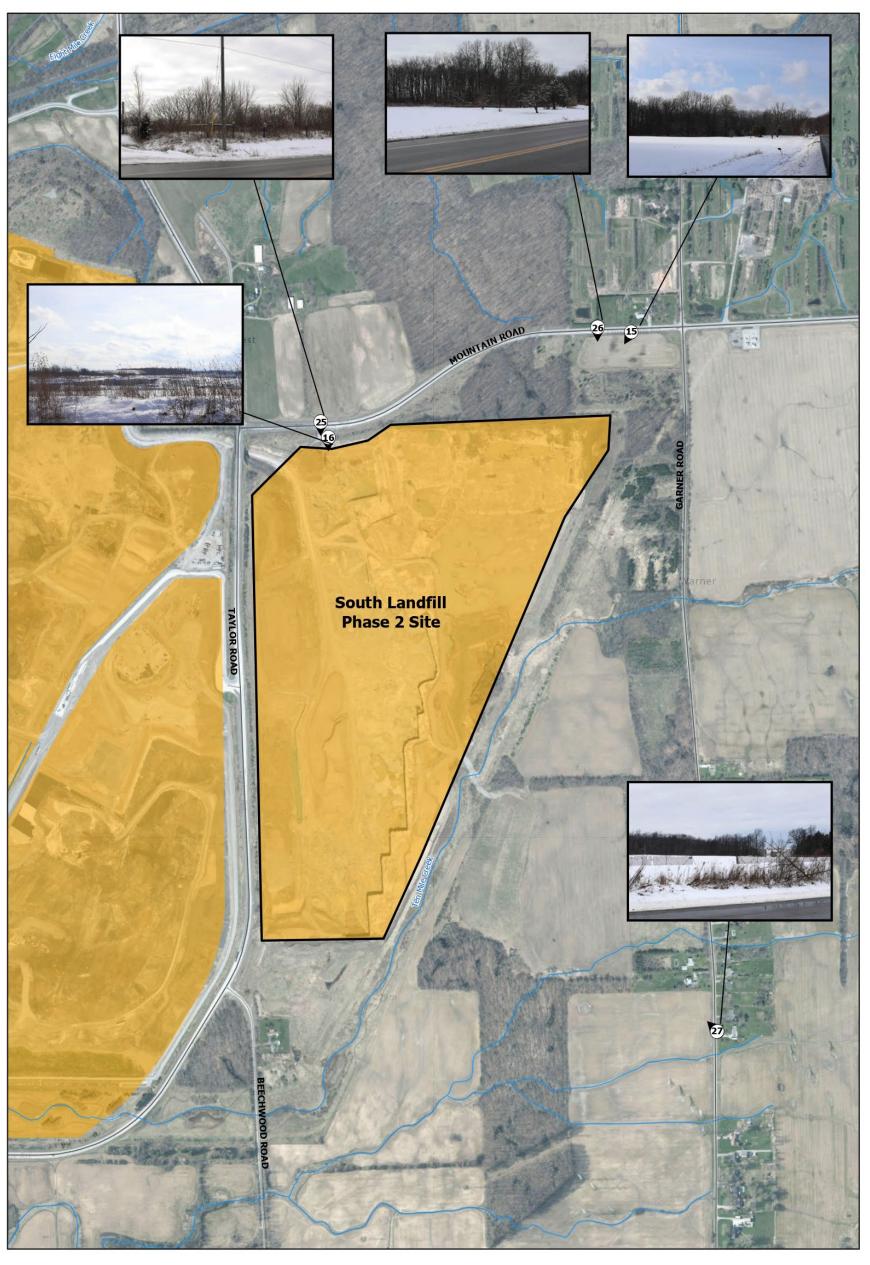
Figure 4.2 Visual Existing Conditions from Photo Locations adjacent to the South Landfill Phase 2 Site, looking in the direction of the Site

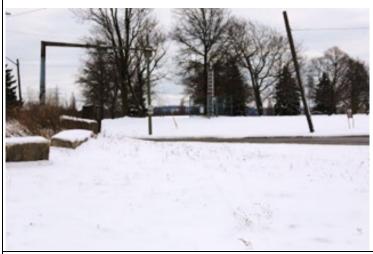
**Photo Location 1:** Glendale Ave Bridge, view facing southwest Existing proposed South Landfill Phase 2 site not visible 43° 8' 44.034" N. 79°11'27.57" W

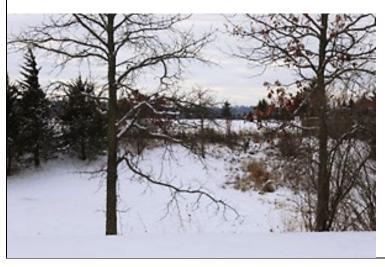
Photo Location 3: Wright Crescent between Keith Cr and Niagara-on the-Green Blvd, view facing south-southeast
Existing proposed South Landfill Phase 2 site not visible
43° 8' 56.448" N, 79° 10' 23.298" W

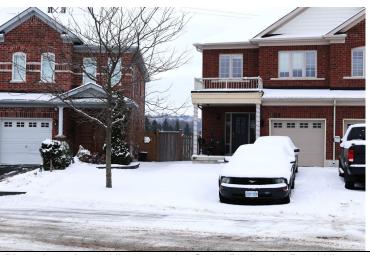
Photo Location 2: Keith Cres, view facing southeast Existing proposed South Landfill Phase 2 site not visible 43° 8' 51.966" N. 79° 10' 38.826" W

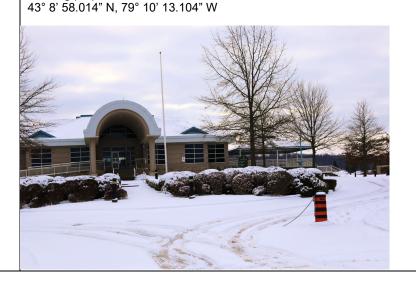
**Photo Location 4:** Niagara-on the-Green Blvd at the Royal Niagara Golf Club, view facing south-southeast Existing proposed South Landfill Phase 2 site not visible

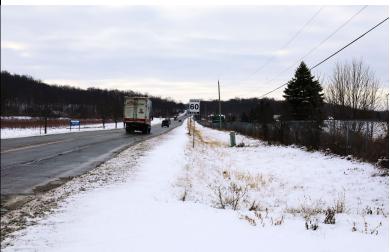
**Photo Location 5:** Taylor Road South of Glendale Avenue, Niagara College's Niagara-on-the-Lake campus, view facing south-southeast Existing proposed South Landfill Phase 2 site not visible 43° 8' 59.58" N, 79° 10' 3.846"W

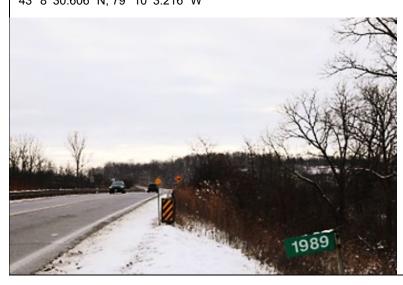
**Photo Location 7:** Taylor Road at Warner Road, Bruce Trail, Woodend Conservation Area, view facing south-southeast Existing proposed South Landfill Phase 2 site not visible 43° 8' 30.606" N, 79° 10' 3.216" W

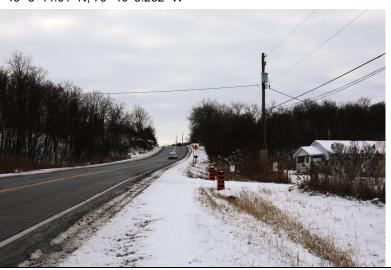
**Photo Location 6:** Taylor Road before the Woodend Conservation Area, view facing south-southeast Existing proposed South Landfill Phase 2 site not visible 43° 8' 44.01" N, 79° 10' 3.282" W

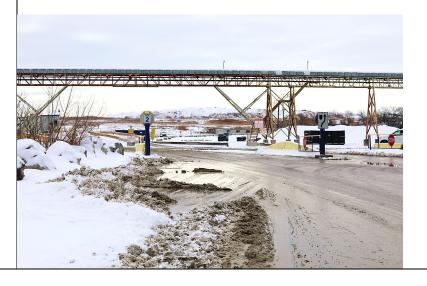
**Photo Location 8:** Walker Campus, view facing southeast Existing proposed South Landfill Phase 2 site visible 43° 8′ 6.93" N, 79° 10′ 24.36" W

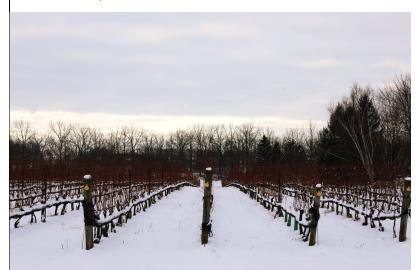
**Photo Location 9:** Warner Road East of Taylor Road, Bruce Trail, view facing south Existing proposed South Landfill Phase 2 site not visible 43° 8' 34.02" N, 79° 9' 49.86"

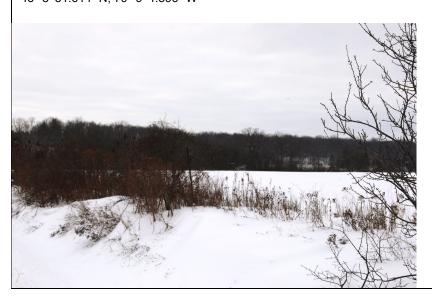
**Photo Location 11:** Garner Road, East of Warner Road, view facing southeast Existing proposed South Landfill Phase 2 site not visible 43° 8' 31.614" N, 79° 9' 4.896" W

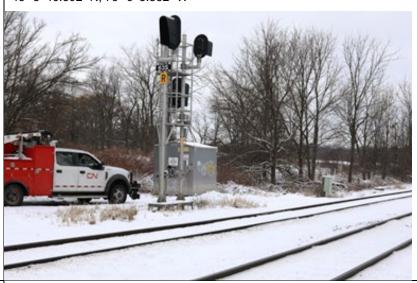
**Photo Location 10:** CN Rail, Garner Road, Bruce Trail, View facing southwest Existing proposed South Landfill Phase 2 site not visible 43° 8' 40.302" N, 79° 9' 5.352" W

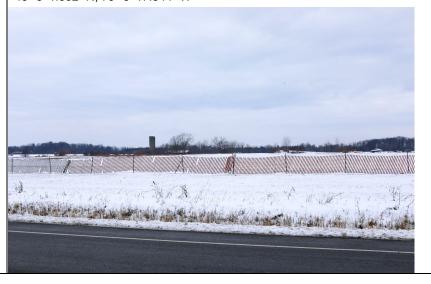
Photo Location 12: Kalar Road and Montrose Road, Club Italia and Regency Athletic Resort/Regency 76, view facing east Existing proposed South Landfill Phase 2 site not visible 43° 8' 1.392" N, 79° 8' 17.844" W

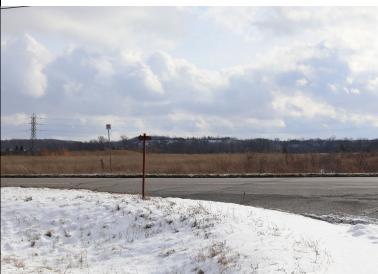
Photo Location 13: Seaway Haulage Road and Glendale Road, view facing southeast

Existing proposed South Landfill Phase 2 site not visible 43° 8' 53.418" N, 79° 11' 0.846" W

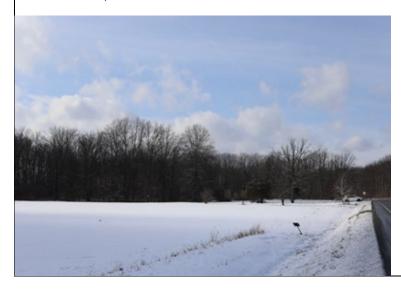
**Photo Location 15:** Mountain Road West of Garner Road, view facing southeast Existing proposed South Landfill Phase 2 site not visible 43° 8' 4.362" N, 79° 9' 9.804" W

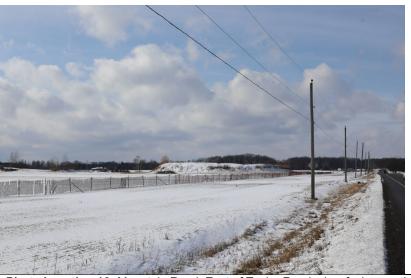
**Photo Location 14:** Mountain Road between Garner Road and Kalar Road, view facing southwest

Existing proposed South Landfill Phase 2 site not visible 43° 8′ 6.084″ N, 79° 8′ 23.922″ W

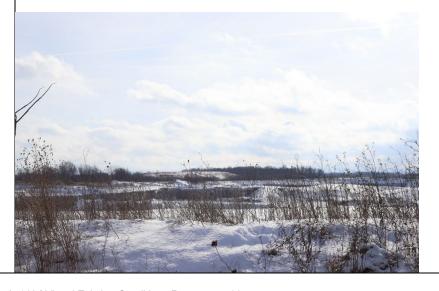
**Photo Location 16:** Mountain Road, East of Taylor Road, view facing south Existing proposed South Landfill Phase 2 site visible 43° 7′ 56.532" N, 79° 9′ 41.082" W

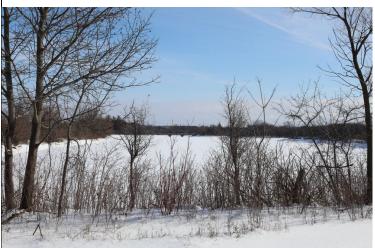
Photo Location 17: Seaway Haulage Road and Hoover Street, view facing east-northeast

Existing proposed South Landfill Phase 2 site not visible 43° 7' 15.054" N, 79° 11' 28.548" W

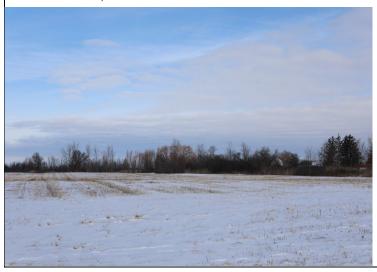
**Photo Location 19:** Beaverdams Road west of Thorold Townline Road, view facing northeast

Existing proposed South Landfill Phase 2 site not visible 43° 6' 15.522" N, 79° 10' 38.988" W

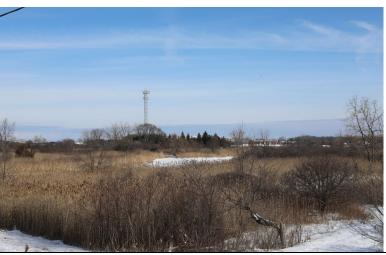
**Photo Location 18:** Davis Road between Niagara Falls Road and Thorold Stone Road, view facing northeast Existing proposed South Landfill Phase 2 site not visible

Existing proposed South Landfill Phase 2 site not visible 43° 6' 35.436" N, 79° 11' 6.072" W

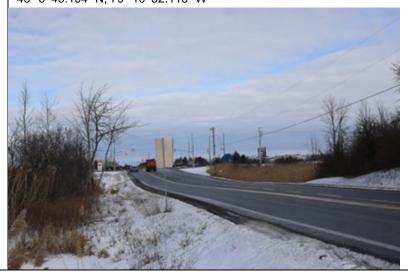
**Photo Location 20:** Thorold Townline Road south of Thorold Stone Road, view facing northwest

Existing proposed South Landfill Phase 2 site not visible 43° 6' 43.104" N, 79° 10' 32.118" W

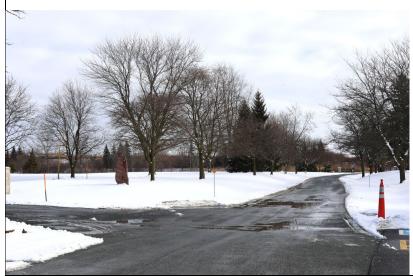
Photo Location 21: Lakeview Cemetery, view facing east Existing proposed South Landfill Phase 2 site not visible 43° 7' 21.618" N, 79° 10' 42.924" W

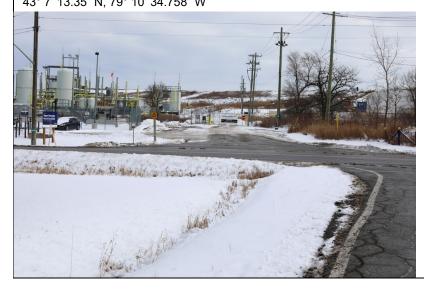
Photo Location 23: Thorold Public Works, Thorold Townline Road, Niagara Region Fleet Garage, view facing ENE Existing proposed South Landfill Phase 2 site not visible 43° 7' 13.35" N. 79° 10' 34.758" W

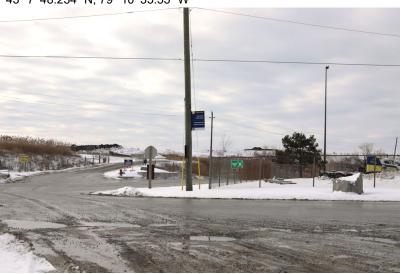
Photo Location 22: Walker Biosolids Facility, Thorold Townline Road, view facing east

Existing proposed South Landfill Phase 2 site not visible 43° 7′ 48.234″ N, 79° 10′ 35.55″ W

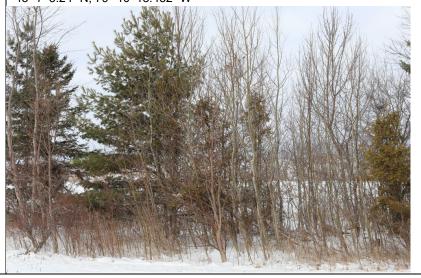
Photo Location 24: Taylor Road east of Thorold Townline Road, view facing northeast

Existing proposed South Landfill Phase 2 site not visible 43° 7' 3.24" N. 79° 10' 18.432" W

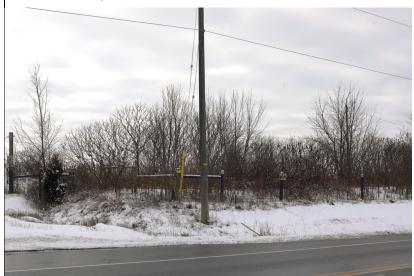
**Photo Location 25:** Mountain Road east of Taylor Road, view facing south Existing proposed South Landfill Phase 2 site not visible 43° 7' 57.684" N, 79° 9' 41.832" W

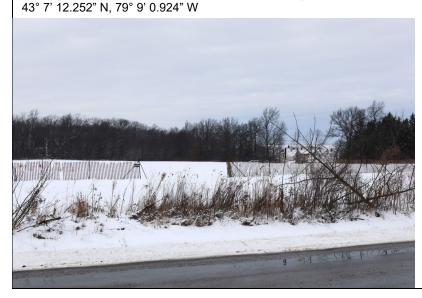
Photo Location 27: Garner Road north of Thorold Stone Road, view facing northwest
Existing proposed South Landfill Phase 2 site partially visible

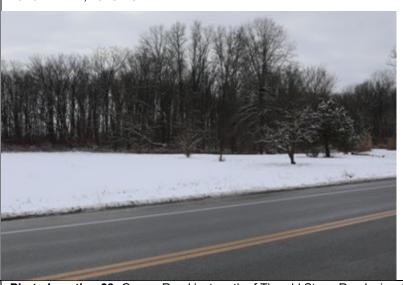
**Photo Location 26:** Mountain Road West of Garner Road, view facing southwest Existing proposed South Landfill Phase 2 site not visible 43° 8' 4.71" N, 79° 9' 13.272" W

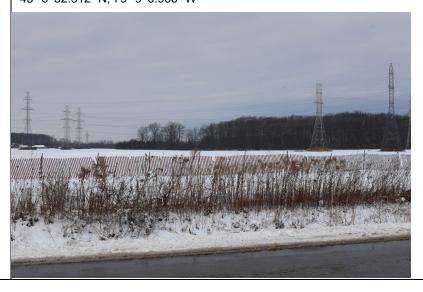
Photo Location 28: Garner Road just north of Thorold Stone Road, view facing northwest
Existing proposed South Landfill Phase 2 site not visible
43° 6' 52.512" N, 79° 9' 0.966" W

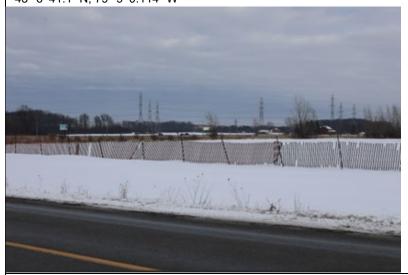
Photo Location 29: Garner Road South of Thorold Stone Road, view facing northwest

Existing proposed South Landfill Phase 2 site not visible 43° 6' 41.1" N. 79° 9' 0.114" W

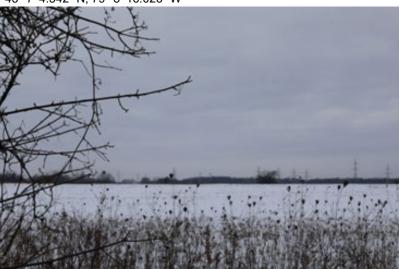
Photo Location 30: Kalar Road North of Thorold Stone Road, Shriner's Woodlot Park, St. Vincent De Paul Catholic Elementary School, view facing northwest Existing proposed South Landfill Phase 2 site partially visible 43° 7' 4.542" N, 79° 8' 16.026" W

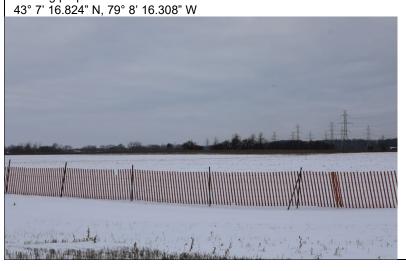
**Photo Location 31:** Kalar Road and Mount Carmel Boulevard, view facing west-northwest Existing proposed South Landfill Phase 2 site not visible
